ARBORIST REPORT & TREE PROTECTION PLAN

13 Mountain St. & 19 - 23 Elm St.

GRIMSBY, ON

Date: September 26, 2024

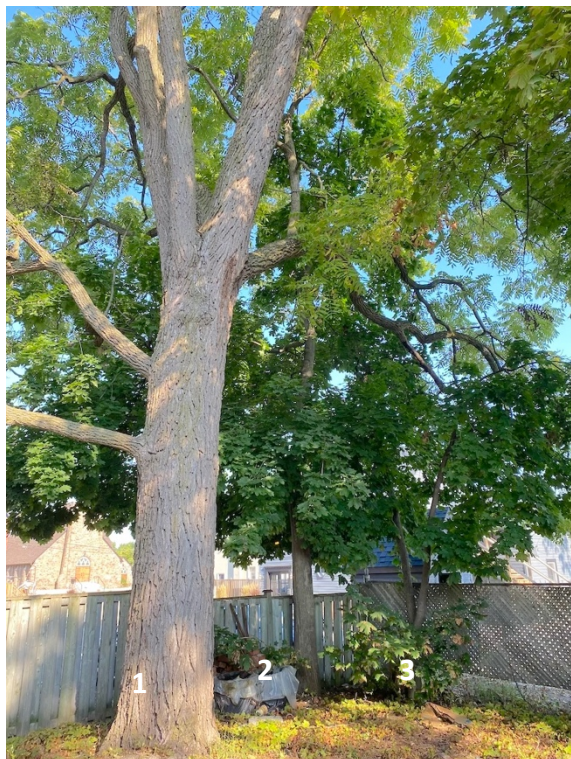
Photo 1. Trees 1 – 3.

Tree #	Species	DBH (cm)	Trunk Integrity	Crown Structure	Crown Vitality	Overall Tree Condition	Ownership	Tree Protection Zone (TPZ)	Condition Comments	Action
1	black walnut (<i>Juglans nigra</i>)	86	Good	Good	Fair	Fair	Subject site	5.4	Asphalt driveway right up the trunk base; large ~20cm dead branch mid crown (recommend pruning); other minor deadwood.	Remove Within footprint of proposed development.
2	Norway maple (<i>Acer platanoides</i>)	31	Fair	Fair	Good	Fair	Subject site	2.4	Poor root flare; growing against property fence; suppressed by adjacent walnut tree; minor bend in trunk; additional stem removed at ground; narrow crack on leader.	Remove Within footprint of proposed development.
3	Norway maple (<i>Acer platanoides</i>)	13,11	Poor	Poor	Fair	Poor	Subject site	1.8	Codominant with narrow union; large cavity at base; suppressed by other trees; poor structure.	Remove Within footprint of proposed development.

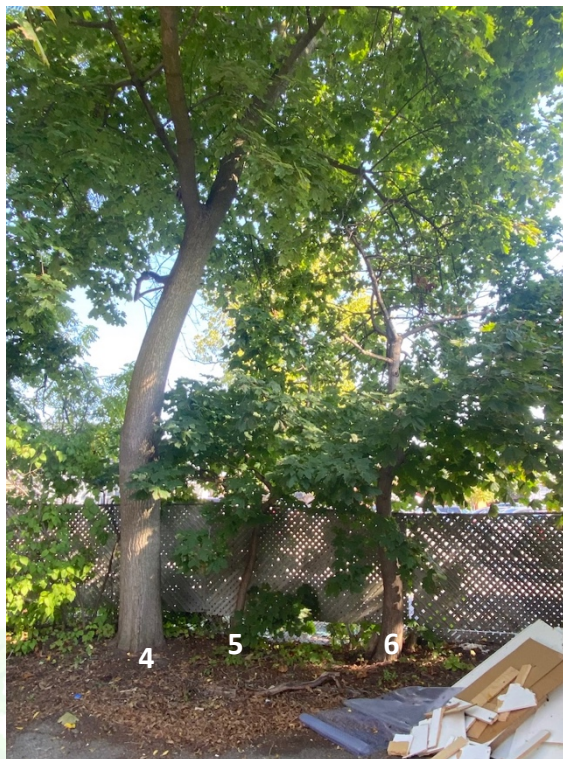
Photo 2. Trees 4-6.

4	Norway maple (<i>Acer platanoides</i>)	42	Poor	Fair	Fair	Fair	Subject site	3	Significant bend in trunk; growing against fence;; leaf scorch affecting 40% of foliage; poor trunk flare.	Remove Within footprint of proposed development.
5	Norway maple (<i>Acer platanoides</i>)	10	Poor	Poor	Fair	Poor	Subject site	1.8	Lacking central leader; poor form (limited scaffold branches); suppressed by surrounding trees.	Remove Within footprint of proposed development.
6	Norway maple (<i>Acer platanoides</i>)	18	Poor	Poor	Fair	Poor	Subject site	1.8	Top dead; bend in trunk; 40% live foliage; growing close to fence.	Remove Within footprint of proposed development.
7	Norway maple (<i>Acer platanoides</i>)	11	Fair	Fair	Fair	Fair	Subject site	1.8	Growing against fence; large exposed roots; bend in trunk extending towards adjacent parking lot.	Remove Within footprint of proposed development.

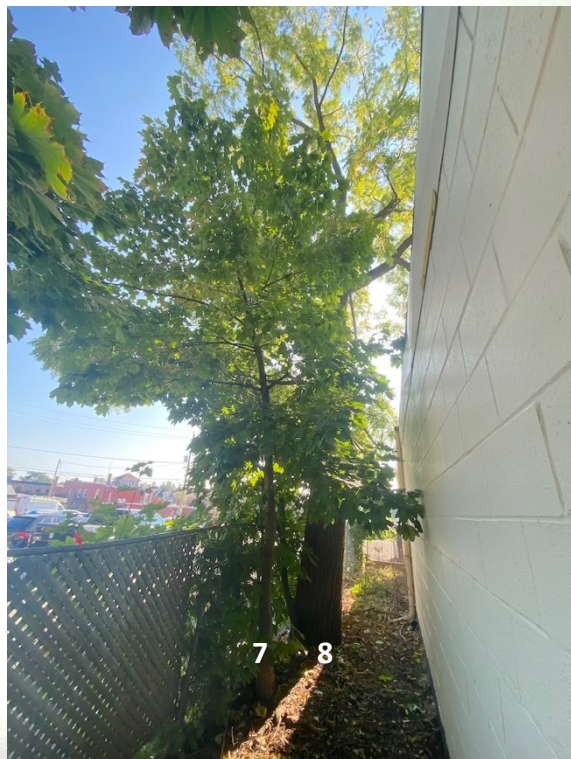
Photo 3. Trees 7 and 8.

Tree #	Species	DBH (cm)	Trunk Integrity	Crown Structure	Crown Vitality	Overall Tree Condition	Ownership	Tree Protection Zone (TPZ)	Condition Comments	Action
8	black walnut (<i>Juglans nigra</i>)	61	Good	Good	Fair	Fair	Subject site	4.2	Chlorosis affecting 25% of foliage; poor trunk flare; minor tip dieback; multiple large (15, 20, 30 cm) diameter pruning wounds; closed over branch stump; old branch tear outs; asphalt near base.	Remove Within footprint of proposed development.
9	Norway maple (<i>Acer platanoides</i>)	11	Poor	Poor	Fair	Poor	Boundary (private)	1.8	Growing intertwined with chain-link fence; limited growth space due to fence and adjacent parking lot; poor structure.	Remove Within footprint of proposed development.
10	Norway maple (<i>Acer platanoides</i>)	60	Good	Fair	Fair	Fair	Subject site	3.6	Buttress roots upheaving patio stocks; poor root growing environment; tip dieback and moderate deadwood; several old pruning wounds.	Remove Within footprint of proposed development.

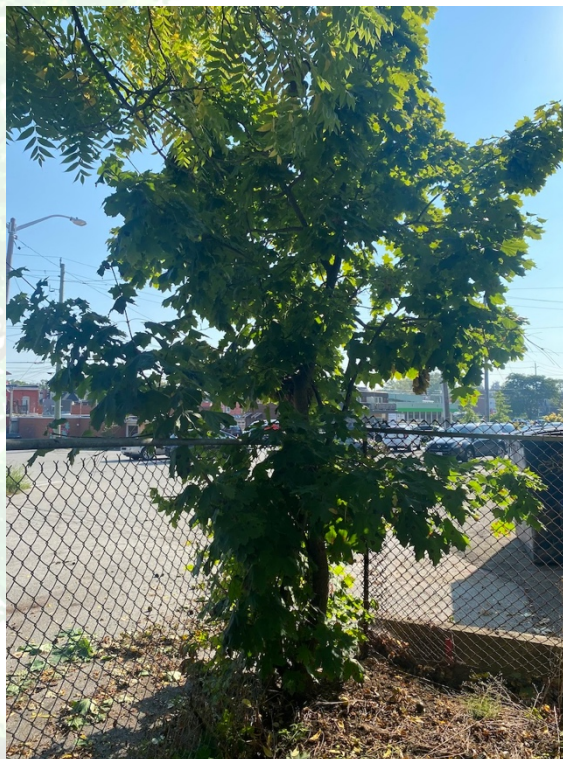
Photo 4. Tree 9.

9	Norway maple (<i>Acer platanoides</i>)	11	Poor	Boundary (private)	1.8	Remove Within footprint of proposed development.
10	Norway maple (<i>Acer platanoides</i>)	60	Fair	Subject site	3.6	Remove Within footprint of proposed development.
11	Colorado spruce (<i>Picea pungens</i>)	42	Good	Subject site	3	Remove Within footprint of proposed development.
12	Norway maple (<i>Acer platanoides</i>)	12	Poor	Subject site	1.8	Remove Within footprint of proposed development.
13	Norway maple (<i>Acer platanoides</i>)	62	Good	Subject site	4.2	Remove Within footprint of proposed development.
14	northern catalpa (<i>Catalpa speciosa</i>)	25	Poor	Subject site	1.8	Remove Within footprint of proposed development.
15	northern catalpa (<i>Catalpa speciosa</i>)	41	Fair	Subject site	3	Remove Within footprint of proposed development.
16	Gallery pear (<i>Pyrus calleryana</i>)	6	Good	Subject site	1.2	Remove Within footprint of proposed development.

3. The removal of any trees located on adjacent private property, or over shared property lines, must be consented to by both owners. 'Boundary' trees (in which any part of the tree from the ground to the first branch crosses over a property boundary), are protected under the Provincial Forestry Act. The consent of all owners for the removal or injury of shared trees is required. On this project, Tree 9 requires the consent of property owner prior to its removal.

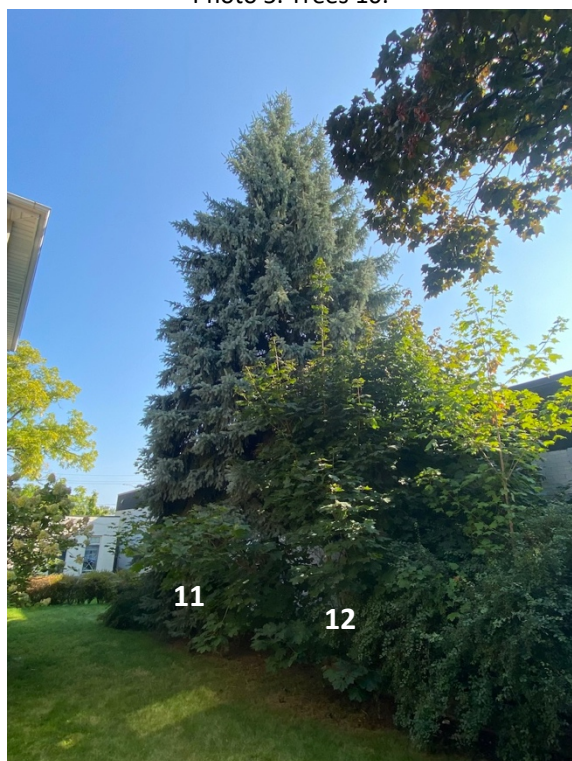
Photo 7. Trees 11 and 12.

11	Colorado spruce (<i>Picea pungens</i>)	42	Good	Good	Good	Good	Subject site	3	Good health and structure; minor deadwood due to shading.	Remove Within footprint of proposed development.
12	Norway maple (<i>Acer platanoides</i>)	12	Poor	Poor	Good - Fair	Poor	Subject site	1.8	Suppressed by other vegetation; one stem dead; poor structure.	Remove Within footprint of proposed development.
13	Norway maple (<i>Acer platanoides</i>)	62	Good	Good	Good	Good	Subject site	4.2	Large surface roots with minor mower damage; well-balanced crown; good branch unions.	Remove Within footprint of proposed development.
14	northern catalpa (<i>Catalpa speciosa</i>)	25	Poor	Poor	Fair	Poor	Subject site	1.8	Near-hollow trunk being tied together with cloth (very little holding wood); fruiting bodies at the base; major epicormic growth.	Remove Within footprint of proposed development.
15	northern catalpa (<i>Catalpa speciosa</i>)	41	Poor	Poor	Fair	Fair	Subject site	3	Major epicormic growth; minor cavities in the upper trunk; chlorosis affecting 60% of foliage.	Remove Within footprint of proposed development.

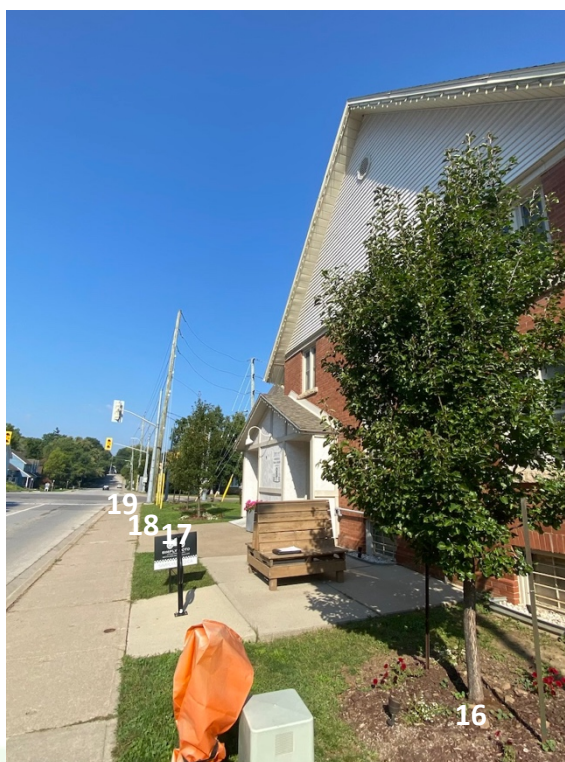
Photo 10. Trees 16-19.

16	Callery pear (<i>Pyrus calleryana</i>)	6	Good	Good	Good	Good	Subject site	1.2	Good health and structure.	Remove Within footprint of proposed development.
17	Callery pear (<i>Pyrus calleryana</i>)	6.5	Good	Good	Good	Good	Subject site	1.2	Good health and structure.	Remove Within footprint of proposed development.
18	Callery pear (<i>Pyrus calleryana</i>)	7	Good	Good	Good	Good	Subject site	1.2	Good health and structure.	Remove Within footprint of proposed development.
19	Callery pear (<i>Pyrus calleryana</i>)	6.5	Good	Fair	Good	Good	Subject site	1.2	Codominant structure.	Remove Within footprint of proposed development.

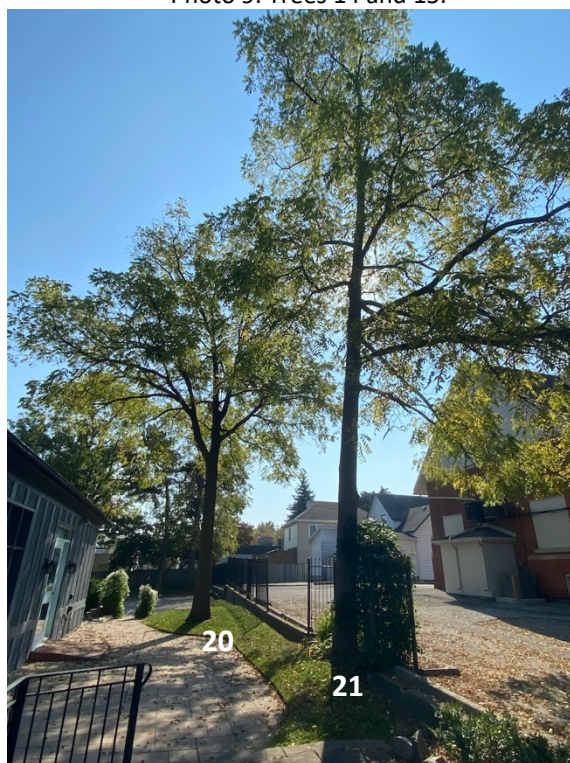
Photo 11. Trees 20 and 21.

Tree #	Species	DBH (cm)	Trunk Integrity	Crown Structure	Crown Vitality	Overall Tree Condition	Ownership	Tree Protection Zone (TPZ)	Condition Comments	Action
20	black walnut (<i>Juglans nigra</i>)	49	Good	Good	Fair	Fair	Subject site	3	Minor chlorosis affecting 60% of foliage; minor tip dieback; growing near patio.	Remove Within footprint of proposed development.
21	black walnut (<i>Juglans nigra</i>)	41	Good	Fair	Fair	Fair	Subject site	3	Somewhat asymmetrical structure due to recently removed tree; limited inner branching.	Remove Within footprint of proposed development.
22	Japanese white pine (<i>Pinus parviflora</i>)	8	Fair	Fair	Good	Fair	Subject site	1.2	Meandering trunk; growing in restricted space (small rocky planter bed).	Remove Within footprint of proposed development.
23	Manitoba maple (<i>Acer negundo</i>)	5,5,4	Fair	Fair	Fair	Fair	Municipal	1.2	Multi-stemmed with all stems under 10cm diameter; competition from surrounding vegetation; fair structure.	Remove Within footprint of proposed development.

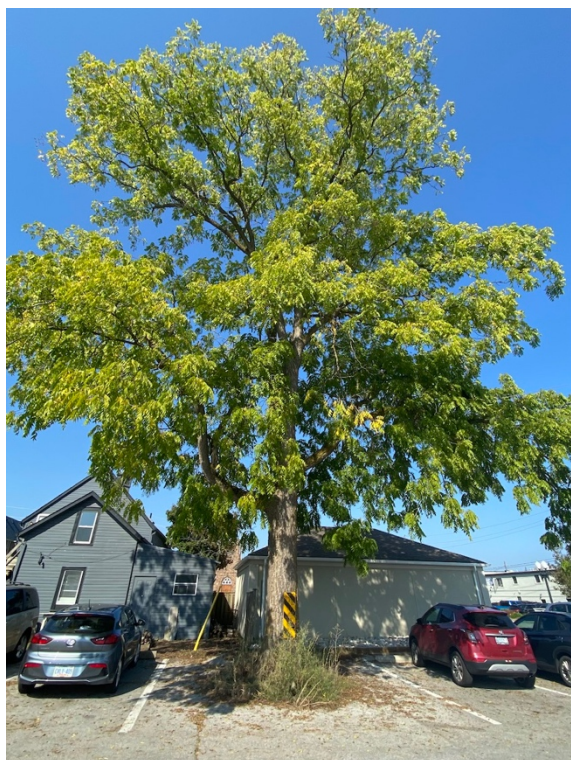
Photo 13. Trees 27.

8. Where there is minimal encroachment into the TPZ, retention of the tree may be possible depending on the amount of root disturbance. On this project, there is a minor encroachment into the TPZ of Tree 27 for the removal of an existing deck and excavation for the underground parking garage up to the property line.

24	black walnut (<i>Juglans nigra</i>)	64	Fair	Fair	Fair	Fair	Subject site	4.2	Multiple large pruning wounds; fair health (chlorosis affecting 30% of foliage); trunk growing very close to parking space edge.	Remove Within footprint of proposed development.
25	Austrian pine (<i>Pinus nigra</i>)	48	Fair	Fair	Fair	Fair	Subject site	3	Growing against fence; bend in trunk towards top of crown; minor Diplodia blight; unbalanced crown to the west.	Remove Within footprint of proposed development.
26	Norway maple (<i>Acer platanoides</i>)	11	Fair	Poor	Fair	Poor	Subject site	1.8	Growing against fence; suppressed by nearby pine; old tear out at 2m (closed over); minor lean; good health.	Remove Within footprint of proposed development.
27	black walnut (<i>Juglans nigra</i>)	81	Fair	Fair	Fair	Fair	Adjacent, private	5.4	Roots upheaving asphalt (very limited root growth space); moderate deadwood; well-balanced structure; minor chlorosis.	Injure Excavation to property line, inside 5% of TPZ, 3.4 m from tree.

9. To minimize disturbance to Tree 27, the excavation along the perimeter of the subject site at the northwest corner of the property line, is to be carried out using root-sensitive methods to a depth of 90 cm inside the TPZ (refer to Appendix III, Tree Protection Plan). Root-sensitive methods include hand-digging, AirSpade, or low-pressure hydrovac excavation. It is recommended that this work be completed under the supervision of a qualified arborist. Any exposed roots are to be cleanly pruned to prevent tearing, subject to the arborist's review that such pruning will not affect the health or structure of the tree. Due to the minimal encroachment into the TPZ, significant root impacts are not anticipated. There are no conflicts with the overhead branches of this tree.

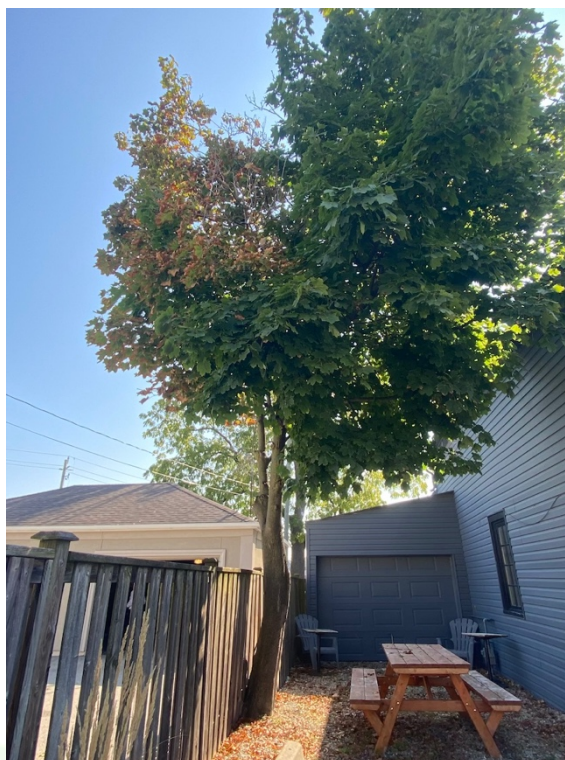
Photo 14. Trees 28.

28	Norway maple (<i>Acer platanoides</i>)	32	Poor	Poor	Fair	Poor	Subject site	2.4	Major longitudinal trunk wound not healed; large (>10cm) pruning wound; growing against fence in confined area; dieback and leaf scorch on branches over fence.	Remove Within footprint of proposed development.
