## 2.2 Site Context

## 5 ASSESSMENT OF EXISTING CONDITION

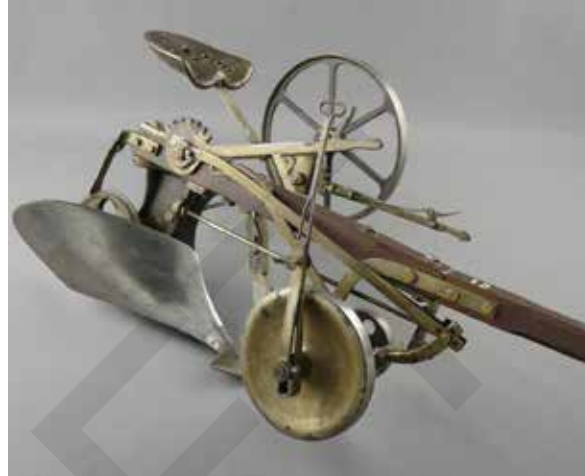
Contemporary photo of John Groat's Sulky Plow, a horse-drawn plough with a seat. This heavy iron plough had a lever to control the depth of the blade. This model one numerous awards (see below) (Grimsby Museum Collection).

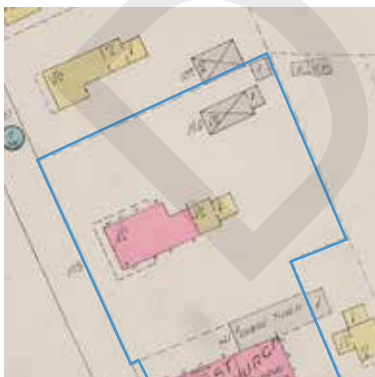
1914 fire insurance plan showing the house's original wrap around front porch (dashed line), likely non-original rough cast additions (yellow) and rear stable/Carriage House (grey) (Brock University Online Archives)

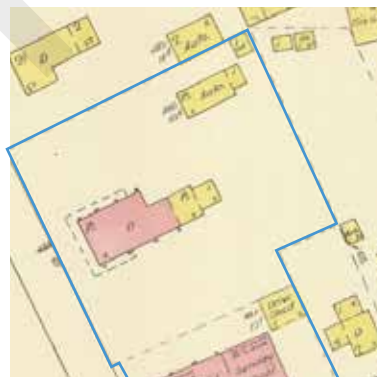
1928 fire insurance plan showing a rough-cast "Auto" shed, or garage (shown in yellow) behind the house (Town of Grimsby).

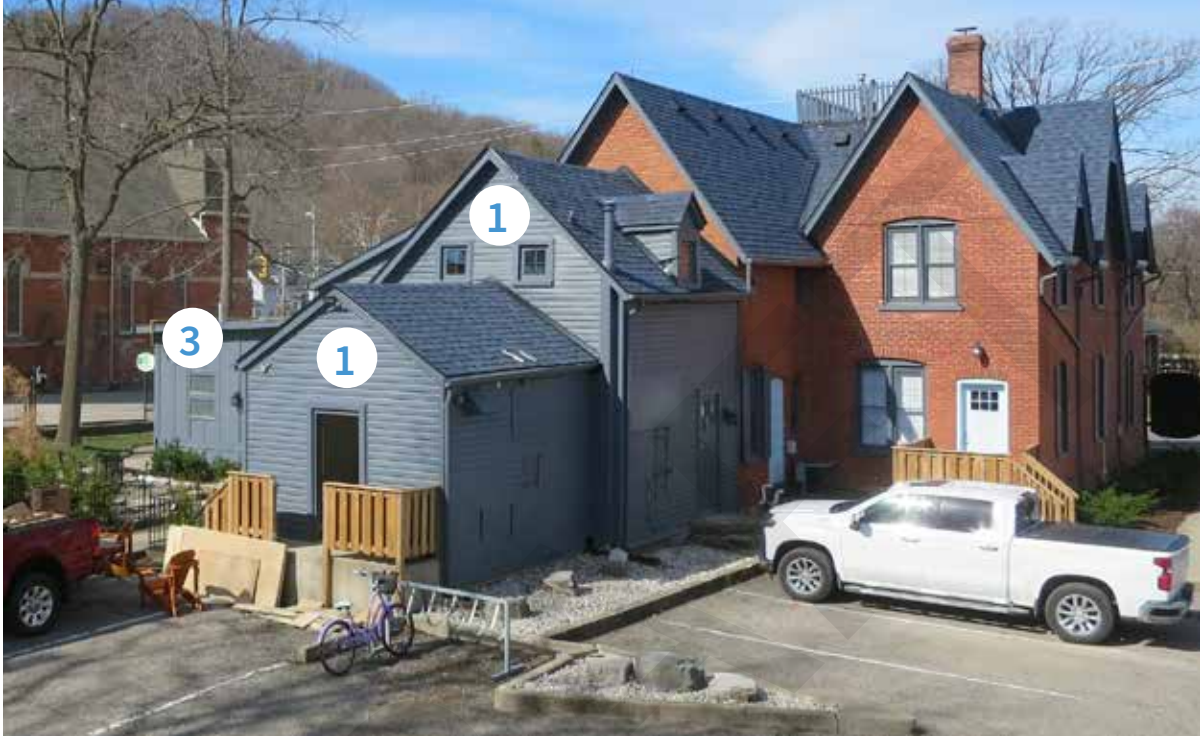
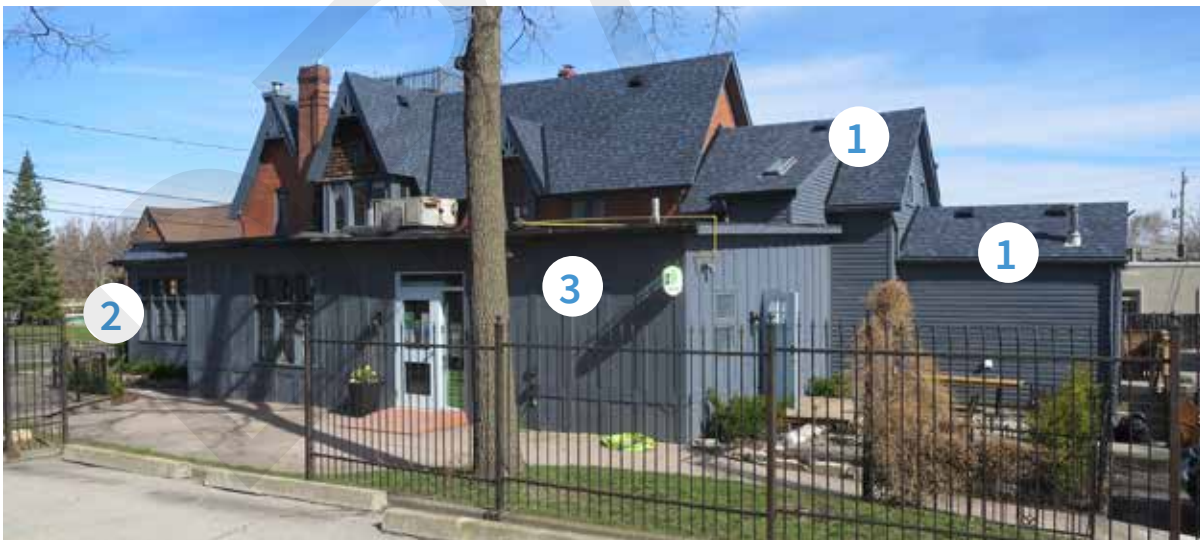
Views of the incremental additions on the house, including (1) the rough cast additions seen in the 1914 and 1928 fire insurance plans, (2) the enclosed sunroom from Lily Selby and Francis Woolverton's tenure beginning in 1933 and (3) a commercial addition from the late 20th century (ERA, 2021).

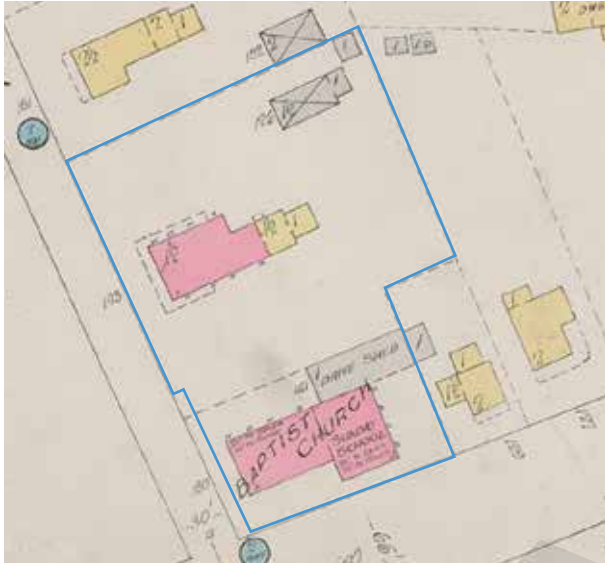
1914 fire insurance plan showing the full Site (outlined in blue). The Church, whose Sunday School addition has just been completed, has an elongated drive shed at the north elevation (Brock University Online Archives)

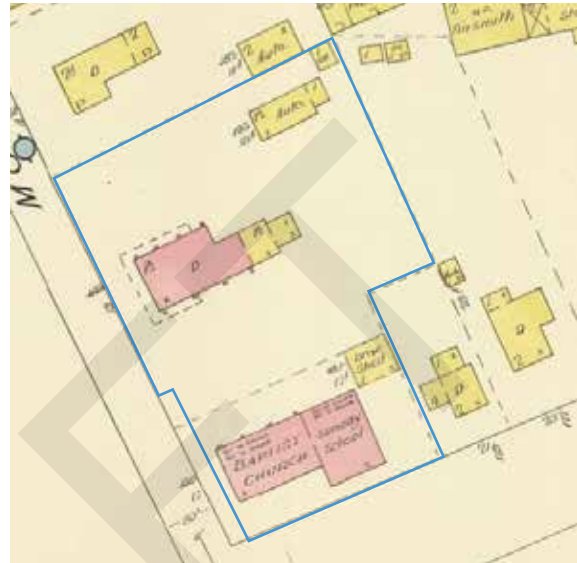
1928 fire insurance plan showing the full Site (outlined in blue). The long drive shed has since been replaced with a smaller rough-cast drive shed at the northeast corner of the property (Town of Grimsby).

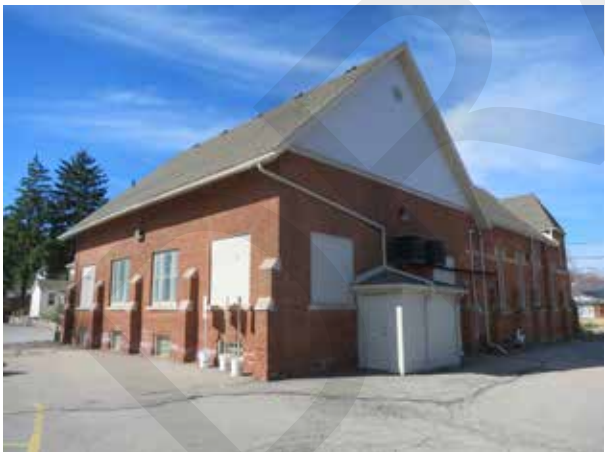
Current photo of the Church showing the east and north elevations of the 1913 Sunday School addition, which was designed with the same brick pier pattern as the original 1880 church. The north elevation of the addition was originally obscured by a drive shed, and is therefore unornamented (ERA, 2021).

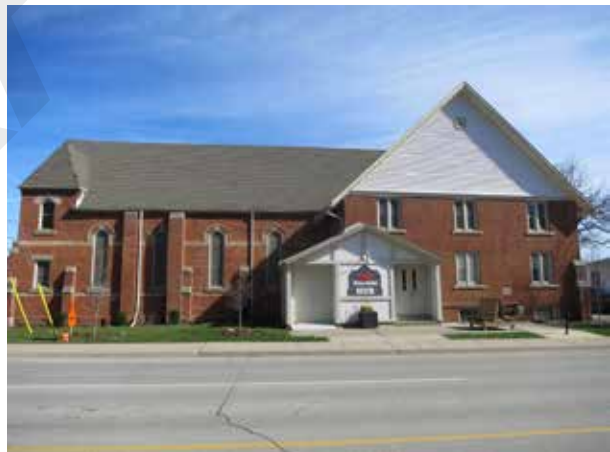
Current photo of the Church showing the south elevation of the 1880 Church (left), a later doorway addition (centre) and the 1913 Sunday School addition (right). The footprint and cross gable of the Sunday School addition somewhat obscures the original 1880 building footprint. The raised basement and first floor stand in contrast to the 1880 church building, whose first floor level sits much closer to grade (ERA, 2021).

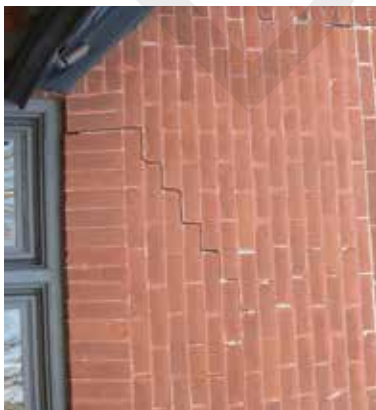
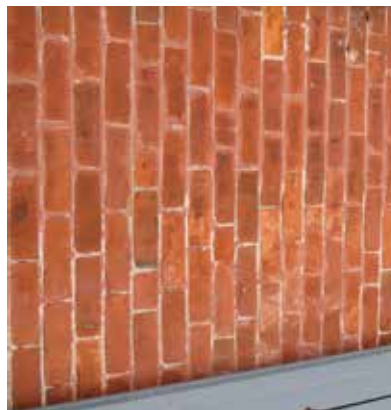
Overall, the main building at 13 Mountain Street appears to be in good condition. The dominant portion of the building is composed of brick laid in common bond, with Flemish headers every sixth course tying the outer wythe of brick to the interior brickwork. There are selective open mortar joints in the exterior brickwork and spalling of occasional bricks where the outer faces have been damaged or fractured. Step cracks in the outer masonry have begun to appear near the southwest corner of the building. The random ashlar stone foundations appear to be in good condition, although there are occasional open mortar joints in these locations as well.

Left: Step-cracks and open mortar joints at southwest corner of building (ERA, 2021).

Right: Spalled brickwork on north elevation (ERA, 2021).

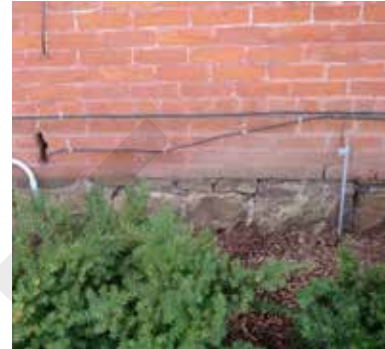
Open mortar joints in brick and stone foundation masonry (ERA, 2021).

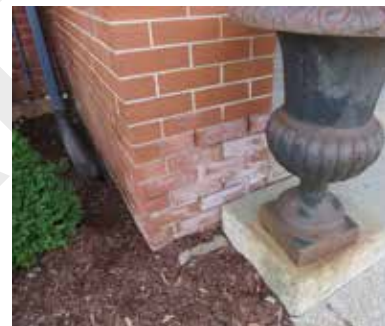
Open mortar joints in brick and stone foundation masonry (ERA, 2021).

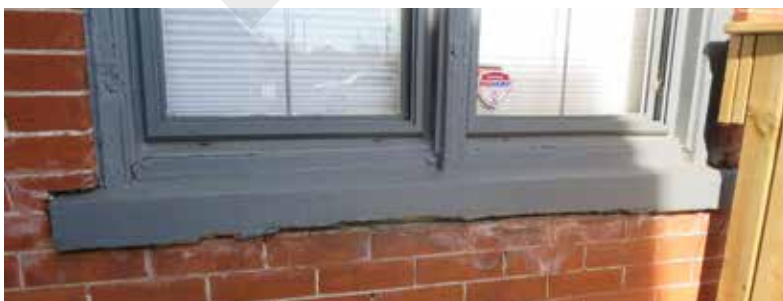
Wood rot in window lug-sill (ERA, 2021).

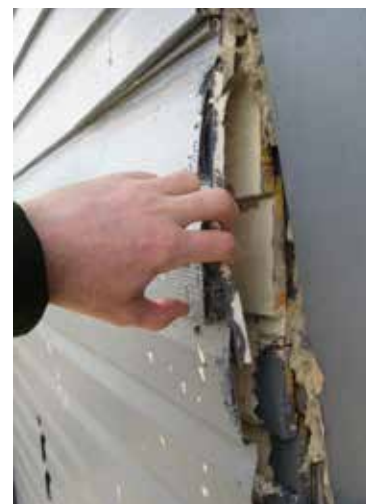
Opening in vinyl siding at rear addition/north elevation revealing wood clapboard siding beneath (ERA, 2021).

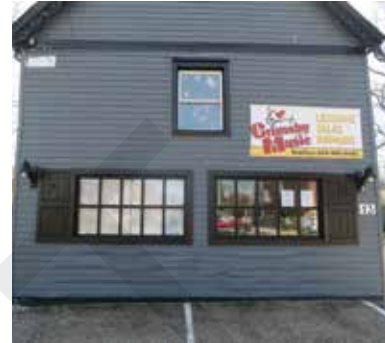
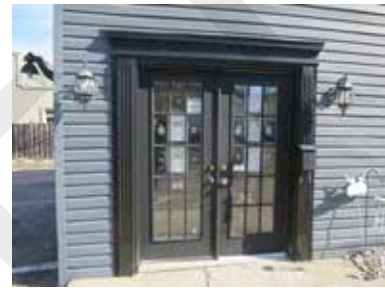
Modern window and door inserts and wood trim (ERA, 2021).

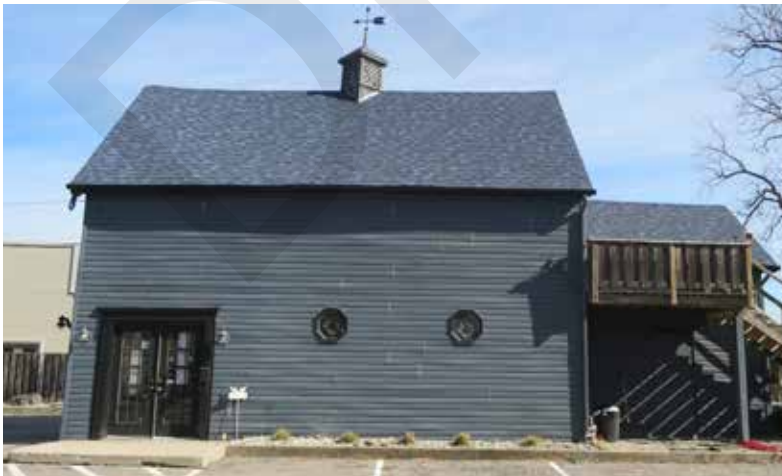
South elevation with uneven vinyl siding installation (ERA, 2021).

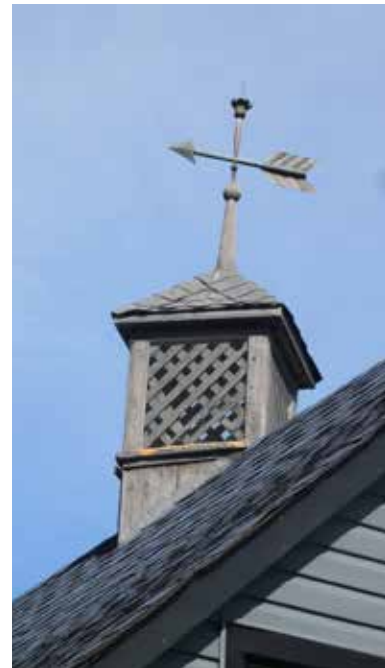
Deteriorated woodwork on roof cupola ventilation structure (ERA, 2021).

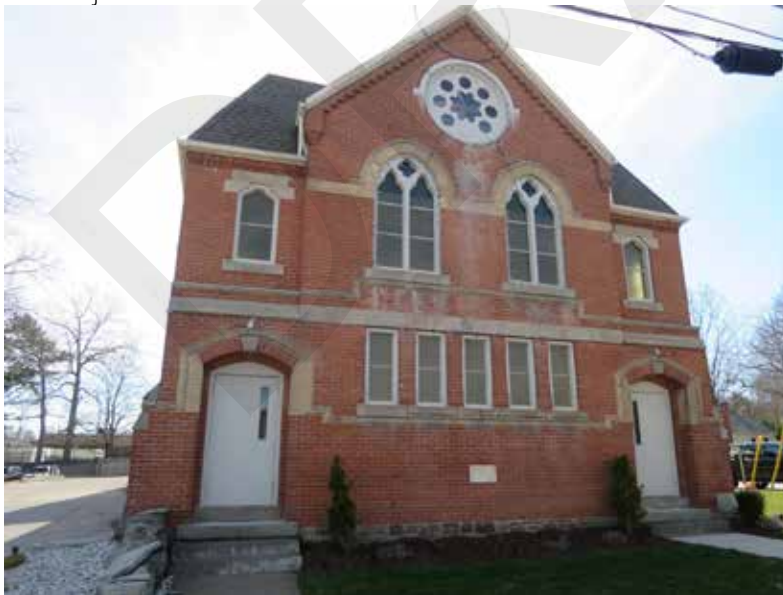
West elevation showing some masonry staining/soiling (ERA, 2021).

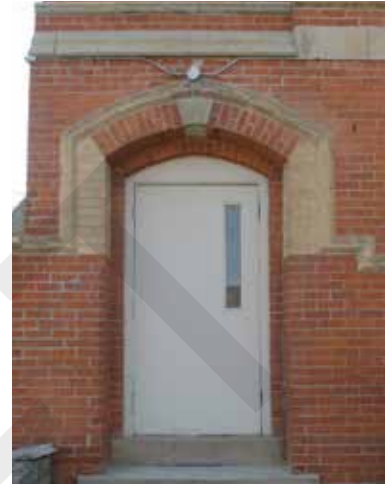
West elevation detail of northern doorway. Remove disused services (ERA, 2021).

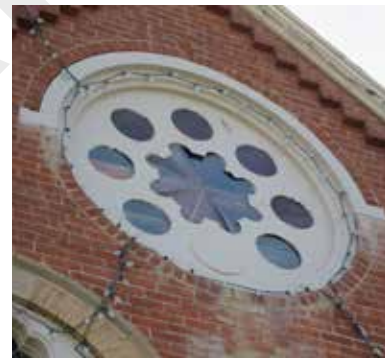
Open joints at perimeter of rose window on west elevation (ERA, 2021).

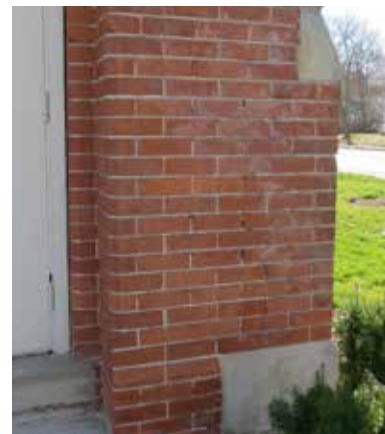
Open brick mortar joints near grade on west elevation (ERA, 2021).

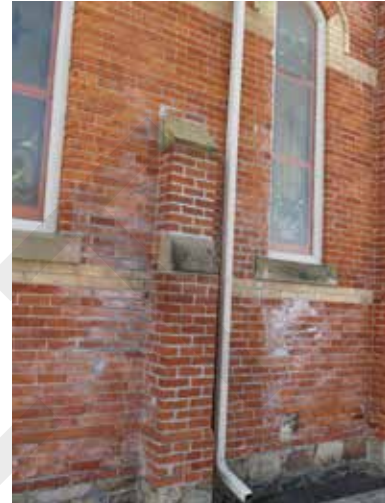
Efflorescence staining on north elevation (ERA, 2021).

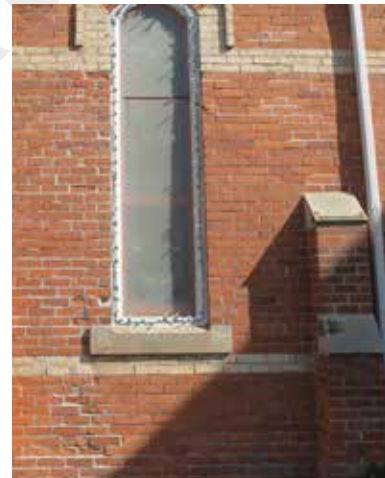
Area of deteriorated/spalled brickwork on south elevation (ERA, 2021).

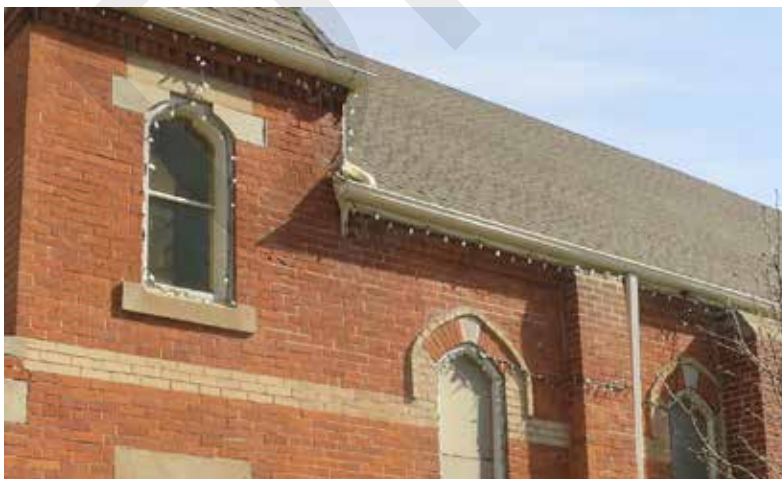
Area of deteriorated/spalled brickwork on south elevation (ERA, 2021).

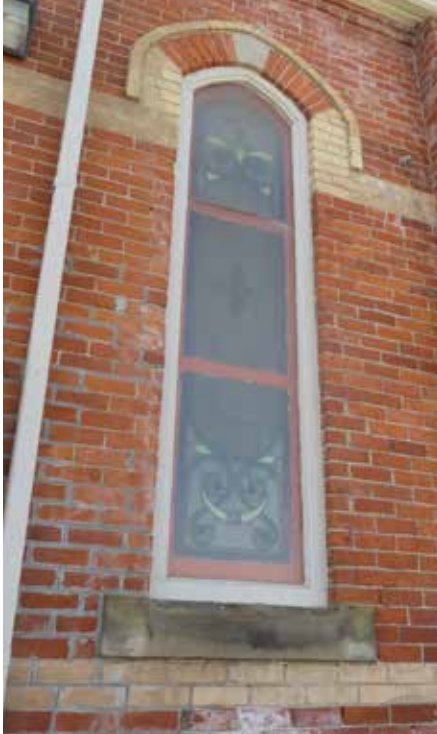
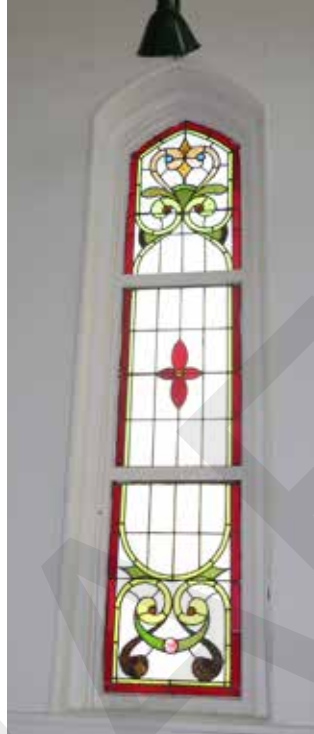
North stained glass window from exterior and interior (ERA, 2021).

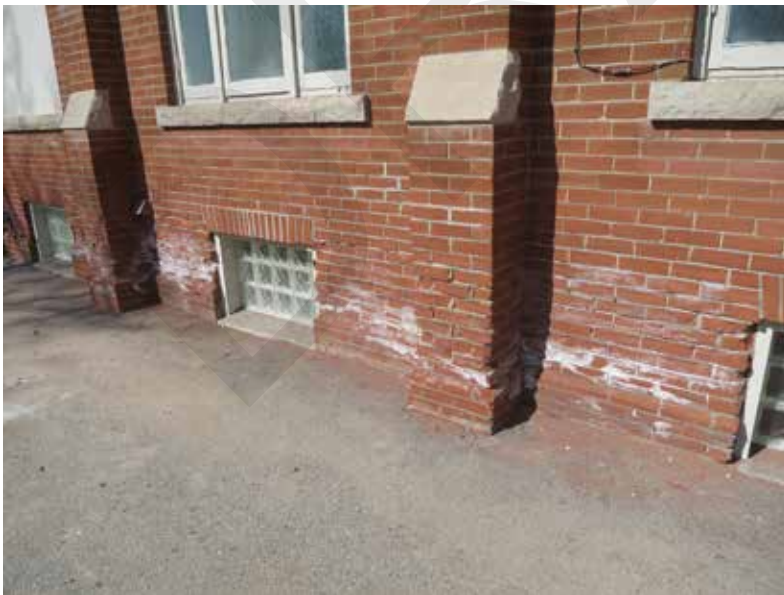
Badly eroded brickwork on east elevation of addition (ERA, 2021).
